**VT TRANSCO, LLC.
East Avenue Loop Project:
Off-ROW Access and RTE
Chittenden County, Vermont
Site Location Map**

VT TRANSCO, LLC.
East Avenue Loop Project (EAL)
Summary of Off-ROW and ROW Access Routes
Pioneer Environmental Associates, LLC.
June 29, 2007

VT TRANSCO, LLC.
 East Avenue Loop Project - Off-ROW Access
 Summary of Jurisdictional Wetlands
 Pioneer Environmental Associates, LLC
 June 29, 2007

Vermont Transco, LLC. (VT Transco)
East Avenue Loop Project – Off-Right-of-Way Access

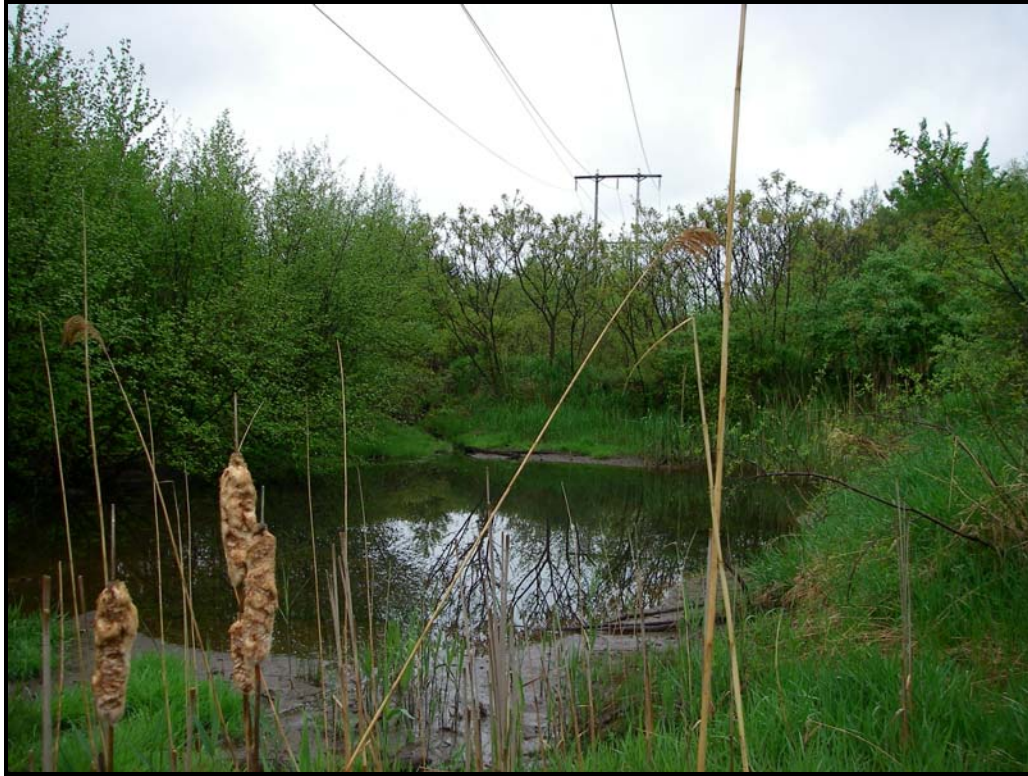
Wetland 2007-1 and 2007-SC-1A

| Wetland Feature Number | PEA Sheet Number | Wetland ID | Town | Total Mapped Area (Sq. ft.) | Class 2 | Class 3 | Transect? | Wetland Vegetation Classification (Cowardin <i>et al.</i> , 1979) | Principle Functions and Values | Fully delineated or extends outside Survey Area/Corridor? | Descriptions and Notes |
|---|---|---|---|---|---|---|---|---|---|---|---|
| 1 | 2 | 2007-01 | Williston | 18,250 | X | | No | PSS1Y | GW, FF, STP, Nut, W | Extends outside survey corridor | Wetland located along topographic depression; drained by SC-1A/TB-1; contains small open water area with amphibians observed; deer observed within wetland; mapped Class Two wetland |

| Drainage Feature Number | PEA Sheet Number | Stream Name | Stream ID | Stream Type | Associated Wetland | Stream Description (Rosgen, D.L., Silvey, H.L., 1996) | Average Ordinary High Water (OHW) Width (Feet) | Notes |
|---|---|---|---|---|---|---|--|--|
| 2 | 2 | Unnamed Trib. Winooski River | 2007-SC-1A | Ephemeral | 2007-1 | - | 1 | Drainage located wholly within wetland 2007-1 |

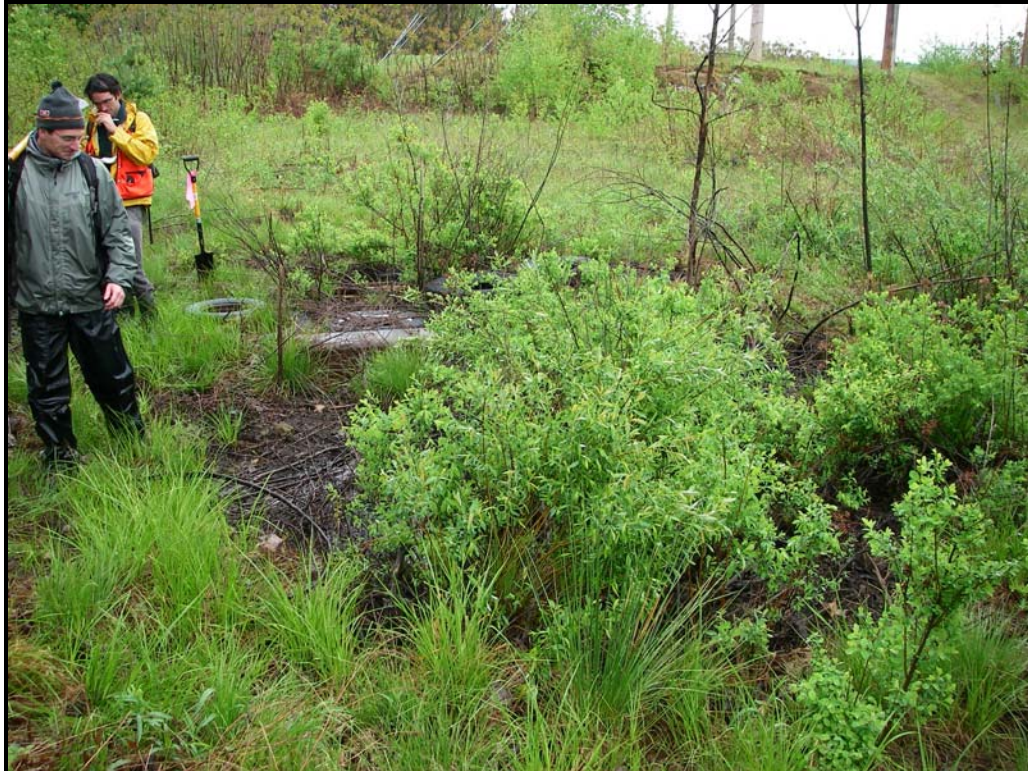
Wetland 2007-2

| Wetland Feature Number | PEA Sheet Number | Wetland ID | Town | Total Mapped Area (Sq. ft.) | Class 2 | Class 3 | Transect? | Wetland Vegetation Classification (Cowardin <i>et al.</i> , 1979) | Principle Functions and Values | Fully delineated or extends outside Survey Area/Corridor? | Descriptions and Notes |
|---|---|---|---|---|---|---|---|---|---|---|---|
| 2 | 2 | 2007-02 | Williston | 1,030 | | X | No | PEM1Y | None | Fully Delineated | Wetland located in borrow pit within disturbed area |

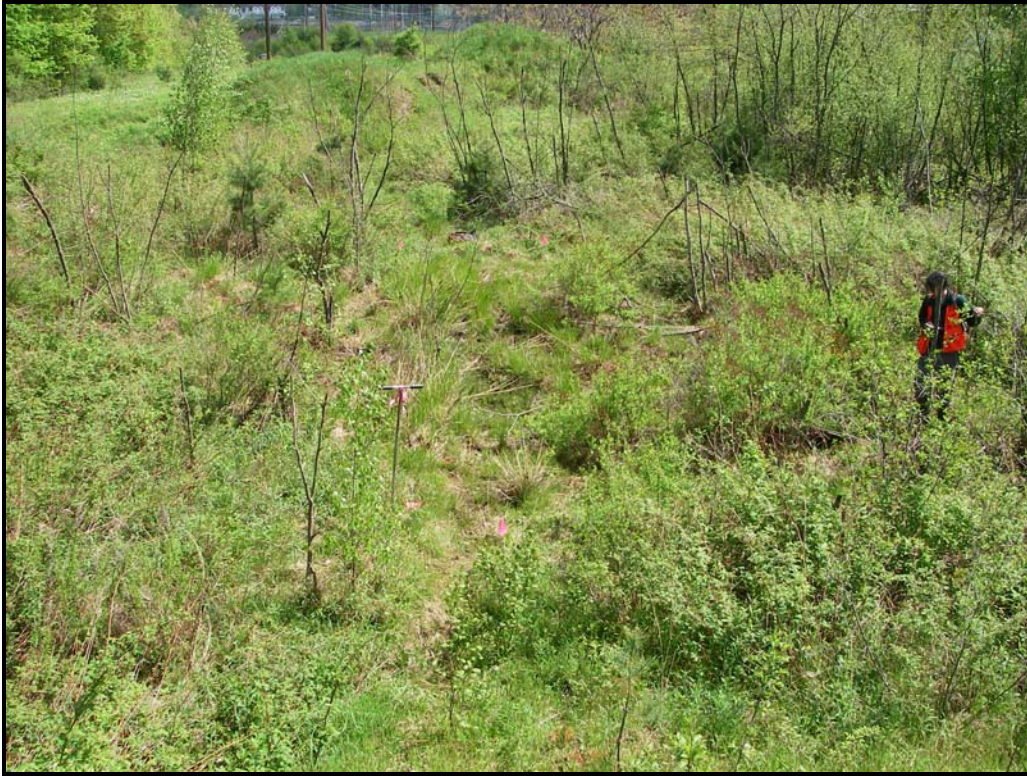
Wetland 2007-3

| Wetland Feature Number | PEA Sheet Number | Wetland ID | Town | Total Mapped Area (Sq. ft.) | Class 2 | Class 3 | Transect? | Wetland Vegetation Classification (Cowardin <i>et al.</i> , 1979) | Principle Functions and Values | Fully delineated or extends outside Survey Area/Corridor? | Descriptions and Notes |
|---|---|---|---|---|---|---|---|---|---|---|---|
| 3 | 2 | 2007-03 | Williston | 2,160 | | X | Yes | PSS1Y | None | Fully Delineated | Wetland located in borrow pit within disturbed area |

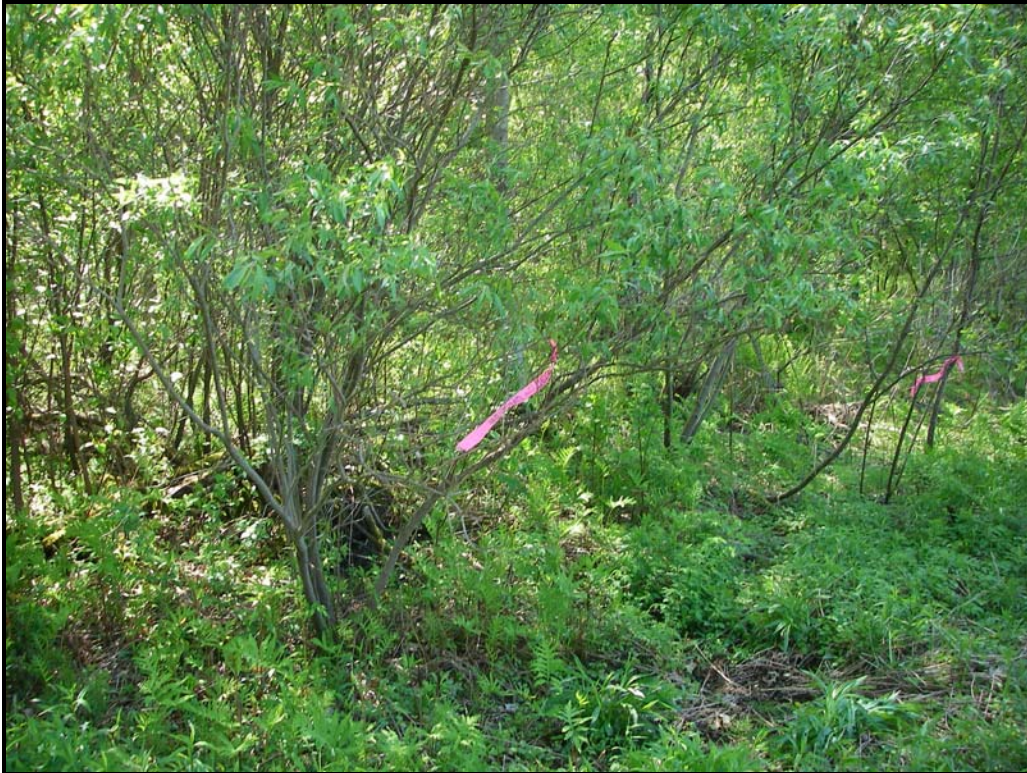
Wetland 2007-5

| Wetland Feature Number | PEA Sheet Number | Wetland ID | Town | Total Mapped Area (Sq. ft.) | Class 2 | Class 3 | Transect? | Wetland Vegetation Classification (Cowardin <i>et al.</i> , 1979) | Principle Functions and Values | Fully delineated or extends outside Survey Area/Corridor? | Descriptions and Notes |
|---|---|---|---|---|---|---|---|---|---|---|---|
| 5 | 7 | 2007-05 | South Burlington | 1,880 | | X | Yes | PSS1Y | GW | Extends outside survey corridor | Wetland a continuation of wetland 2006-09; located near farm field access and corn field |

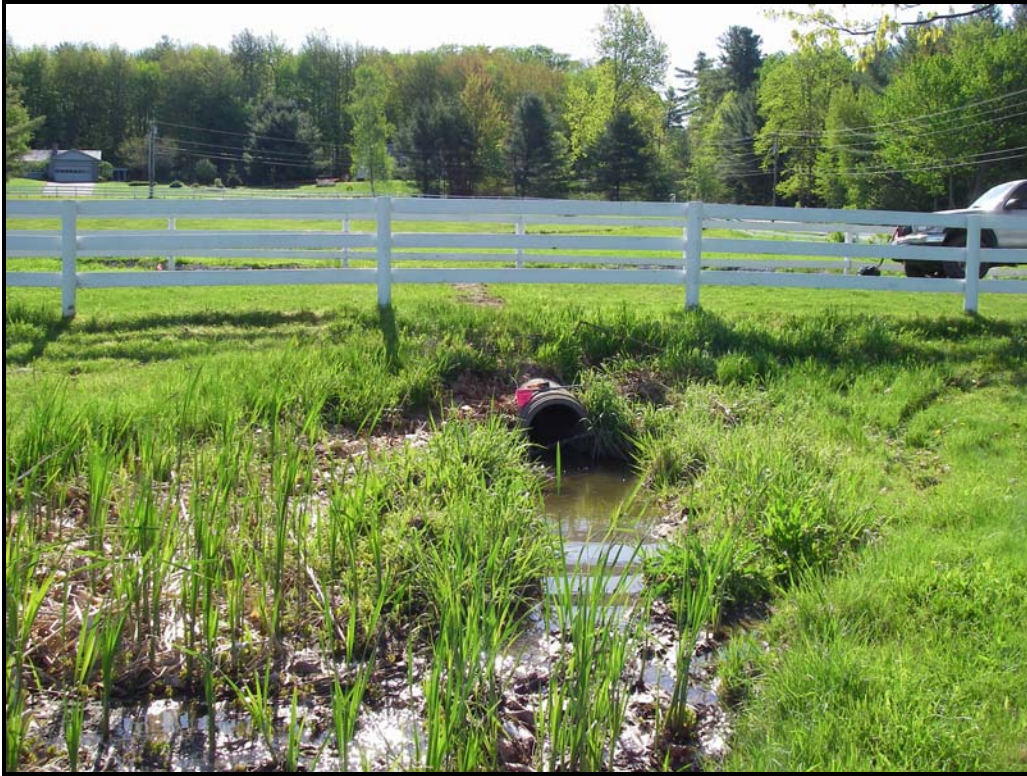
Wetland 2007-8 and 2007-SC-2

| Wetland Feature Number | PEA Sheet Number | Wetland ID | Town | Total Mapped Area (Sq. ft.) | Class 2 | Class 3 | Transect? | Wetland Vegetation Classification (Cowardin <i>et al.</i> , 1979) | Principle Functions and Values | Fully delineated or extends outside Survey Area/Corridor? | Descriptions and Notes |
|---|---|---|---|---|---|---|---|---|---|---|---|
| 8 | 4 | 2007-08 | Williston | 130 | | X | No | PEM1Y | STP, Nut | Extends outside survey corridor | Emergent wetland located along SC-2 (outlet of pond - 2007-7); continues outside survey corridor |

| Drainage Feature Number | PEA Sheet Number | Stream Name | Stream ID | Stream Type | Associated Wetland | Stream Description (Rosgen, D.L., Silvey, H.L., 1996) | Average Ordinary High Water (OHW) Width (Feet) | Notes |
|---|---|---|---|---|---|---|--|--|
| 3 | 4 | Unnamed Trib. Winooski River | 2007-SC-2 | Ephemeral | 2007-7, 2007-8 | - | 3 | Culverted (18" concrete) outlet to pond (2007-7) located within wetland 2007-8; ill defined banks; organic substrate |

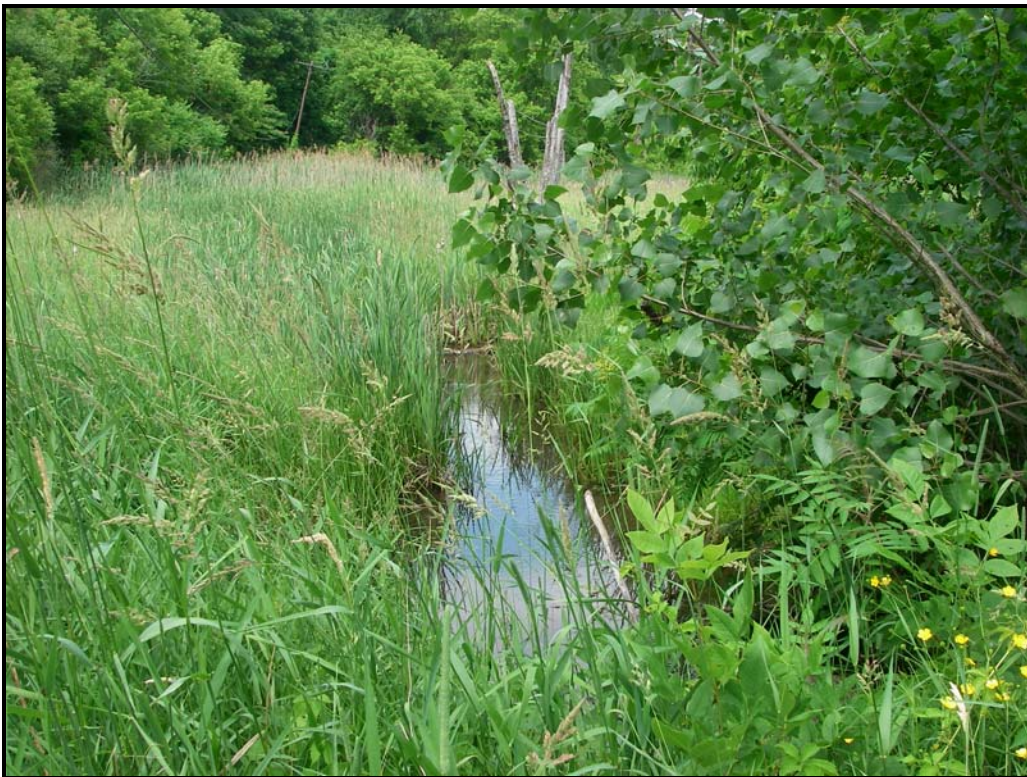
Wetland 2007-9 and 2007-SC-3

| Wetland Feature Number | PEA Sheet Number | Wetland ID | Town | Total Mapped Area (Sq. ft.) | Class 2 | Class 3 | Transect? | Wetland Vegetation Classification (Cowardin <i>et al.</i> , 1979) | Principle Functions and Values | Fully delineated or extends outside Survey Area/Corridor? | Descriptions and Notes |
|---|---|---|---|---|---|---|---|---|---|---|---|
| 9 | 17 | 2007-09 | Winooski | 9,940 | X | | Yes | PEM1J | STP, Nut, FF, W | Extends outside survey corridor | Emergent wetland located along SC-3 with a diversity of marsh habitat, proximal to urban area and Winooski River |

| Drainage Feature Number | PEA Sheet Number | Stream Name | Stream ID | Stream Type | Associated Wetland | Stream Description (Rosgen, D.L., Silvey, H.L., 1996) | Average Ordinary High Water (OHW) Width (Feet) | Notes |
|---|---|---|---|---|---|---|--|--|
| 4 | 17 | Unnamed Trib. Winooski River | 2007-SC-3 | Perennial | 2007-4, 2007-9 | Rosgen classification of E6 | 10 | Upstream of culvert, stream channel less defined, wetland vegetation in channel, downstream cobble substrate, moderated embeddedness |

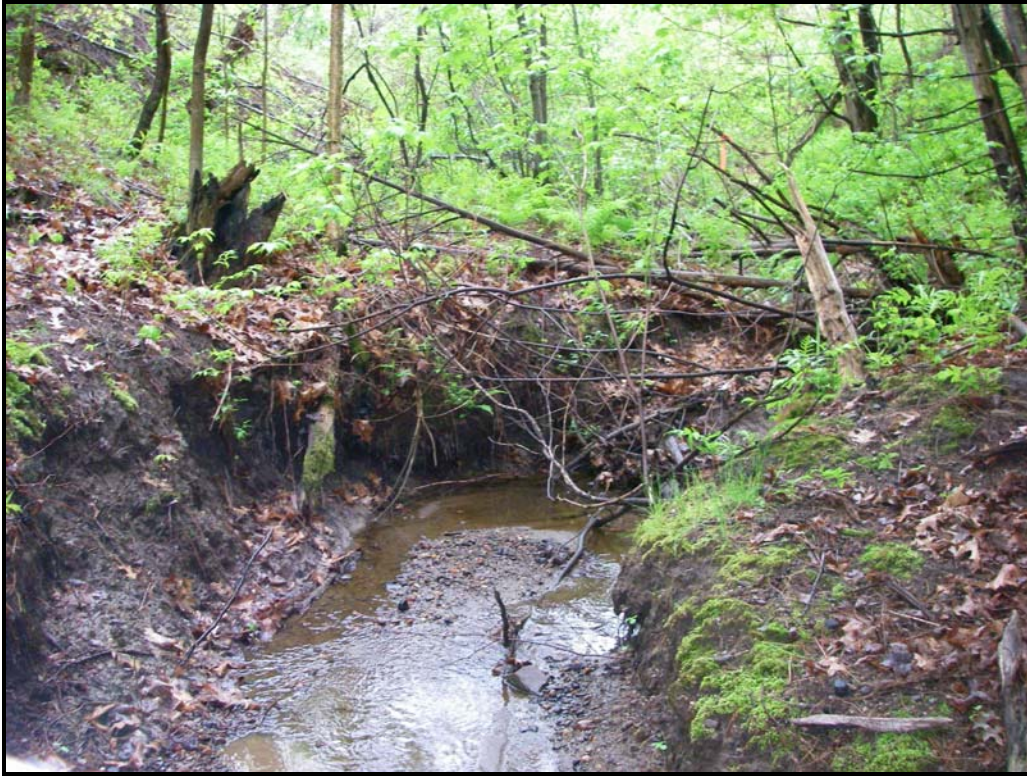
Stream 2007-TB-1

| Drainage Feature Number | PEA Sheet Number | Stream Name | Stream ID | Stream Type | Associated Wetland | Stream Description (Rosgen, D.L., Silvey, H.L., 1996) | Average Ordinary High Water (OHW) Width (Feet) | Notes |
|---|---|---|---|---|---|---|--|--|
| | 2 | | 2007-TB-1 | Perennial | 2007-1 | Rosgen classification of G4 | 7 | Stream draining wetland 2007-1; continuation of SC-1A; well defined banks, located in gully (5-15+ ft. deep); large amount of refuse; debris; high bank erosion; high embeddedness; same stream as TB-1 located within ROW |
